| <b>Report Title</b> | Addendum to the Aboriginal Cultural Heritage Assessment Wellington North Solar Plant - Draft |

# Addendum Aboriginal Cultural Heritage Assessment

WELLINGTON NORTH SOLAR PLANT

JANUARY 2019

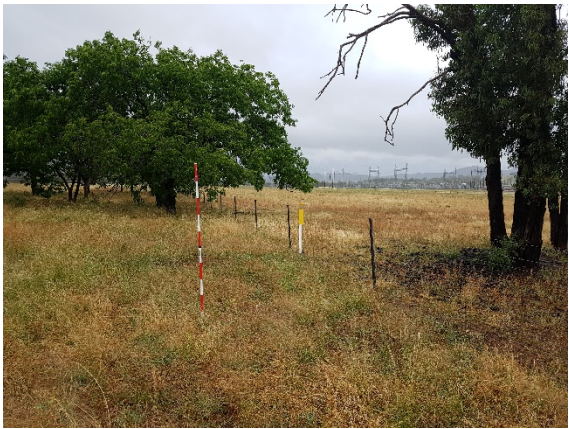
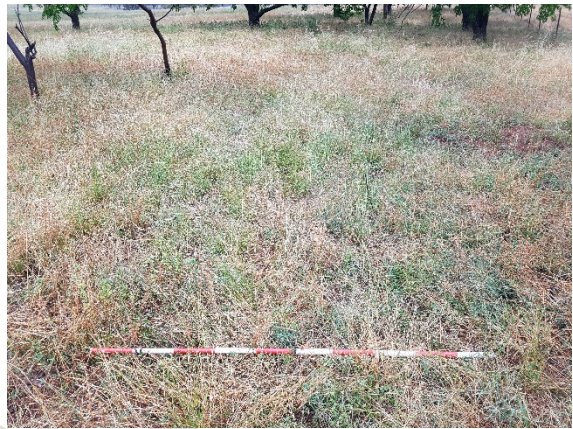
| <p>Plate 1. Transect 1 undertaken on the south-western area of the site. Mature trees and minimal ground visibility. Some disturbance along the fence line due to a tele communications fibre optic cable.</p> | <p>Plate 2. Transect 1 - No ground exposure in the south-western section of the additional project area.</p> |

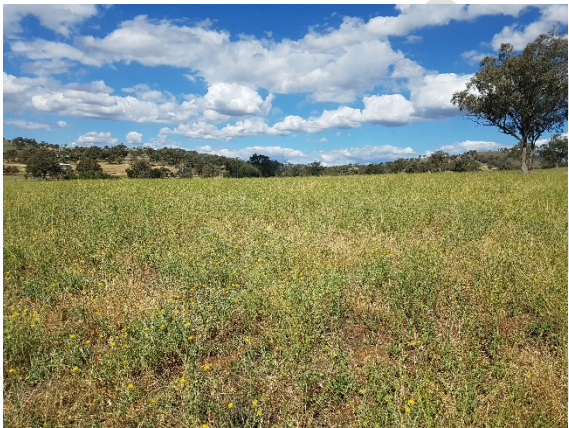
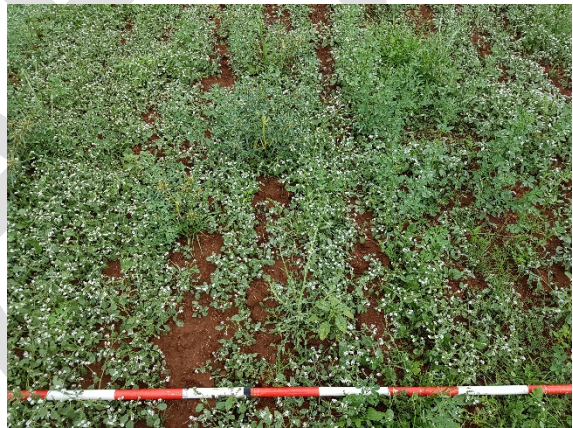
| <p>Plate 3. Rise and granite outcrop to the north of Wuuluman Creek. Hill slopes between 5° and 30°.</p> | <p>Plate 4. Transect 6 – Visibility approximately 40% due to plough lines. Soil comprises of a reddy brown clay material with high content of angular gravels.</p> |

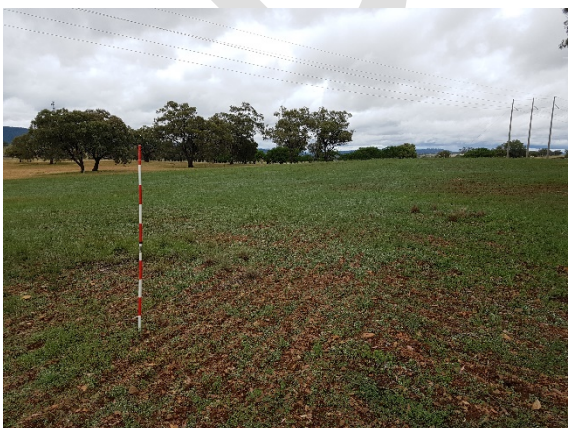
| <p>Plate 5. Transect 7 – The topography included channels and undulating low hills surrounding the area.</p> | <p>Plate 6. – Transect 8 – Ground cover is dense with vegetation at ankle to knee height covering approximately 70% of the ground.</p> |

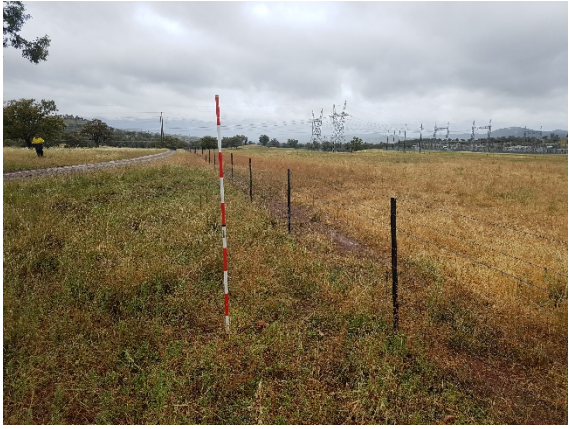
| <p>Plate 7. Transect 1 undertaken on the south-western area of the site. Some disturbance along the fence line due to a tele communications fibre optic cable.</p> | <p>Plate 8. Transect 2 - Ground exposure within the western-most paddock. Exposure of the paddock was approximately 20% with visibility at less than 10%.</p> |

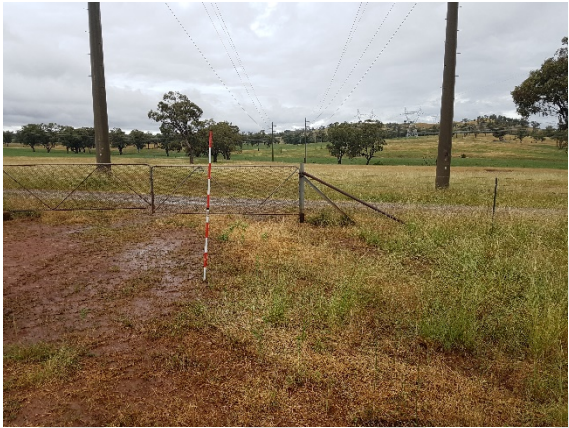
| <p>Plate 9. Transect 2 - Ground exposure within the western-most paddock. Exposure of the paddock was approximately 20% with visibility at less than 10%.</p> | <p>Plate 10. Transect 6 – Visibility approximately 40% due to plough lines. Soil comprises of a reddy brown clay material with high content of angular gravels.</p> |

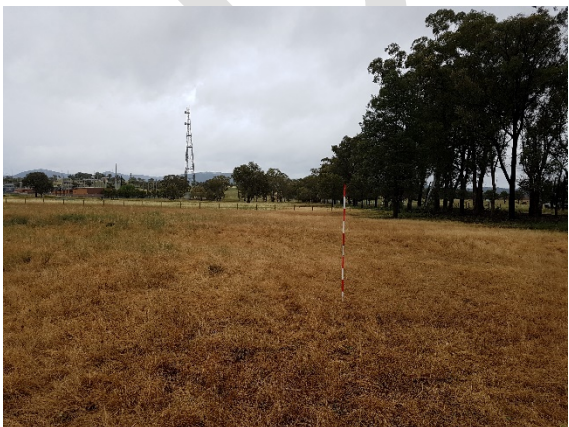
| <p>Plate 11. Transect 7 – The topography included channels and undulating low hills surrounding the area.</p> | <p>Plate 12. – Transect 8 – Ground cover is dense with vegetation at ankle to knee height covering approximately 70% of the ground.</p> |

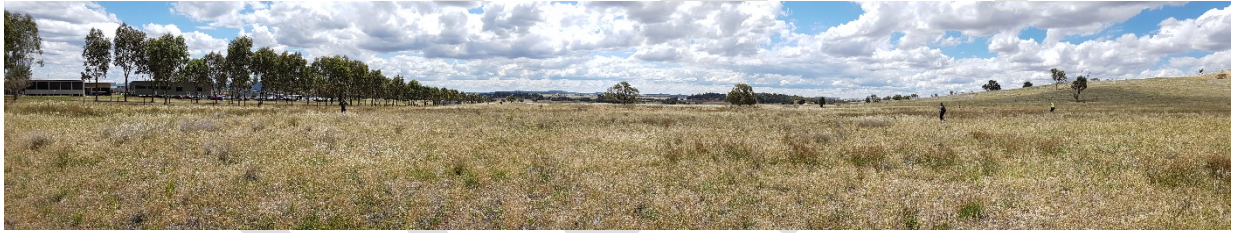
| <p>Plate 33. Panoramic view of the northern section of the transmission line. Wellington Correctional Centre located to the left (south) behind the line of trees. Low visibility and some landscaping channels present throughout the project area which constitute ground disturbance.</p> | |
